# UTILI

# GRAM

January/February 2007

## Water Production Plant Briefly Taken Offline for Minor Repairs

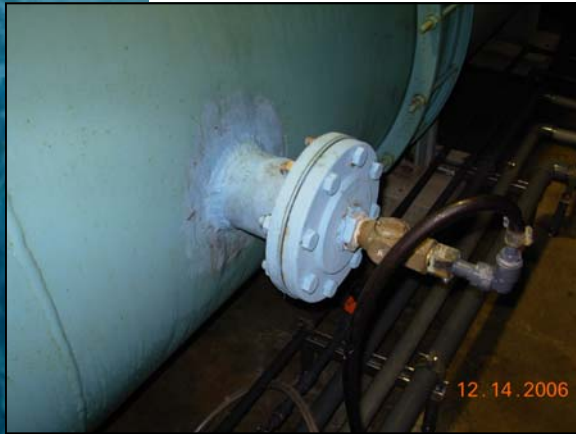
Chemical Feed Pipe Before Repair

To make these repairs, the flanges for two of the chemical feeds had to be completely cut off from the main water feed pipe and new flanges welded into place. Once the flanges were cut off, there would be no turning back. Therefore everything had to be ready to go, including having the new flanges pre-fabricated and test-fitted to the pipe. Being completely satisfied that everything was ready to go, a date was scheduled with the contractor to perform the repairs. On the day of the repairs, plant operators made sure that all of the storage tanks were topped off with water. At approximately 9:00 p.m. the main valve was closed to isolate the feeder pipe from the system and another valve was opened to allow water to drain from inside the feeder pipe. As practiced once before, the Utility began monitoring tank levels and pressure gauges to ensure that the system was operating according to plan. The contractor arrived at approximately 11:00 p.m. and within two hours, the repairs had been made. This may seem like a lot to go through for a two-hour repair; however when it comes to water, you can never be too careful. Added benefits to this operation was training of the Water Utility staff and the assurance that the system can be operated in this manner.

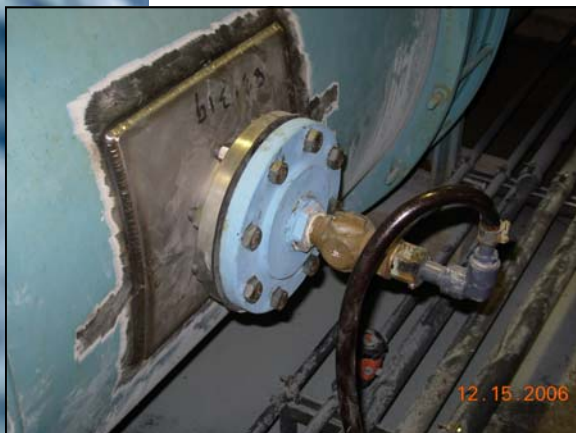
Chemical Feed Pipe After Repair

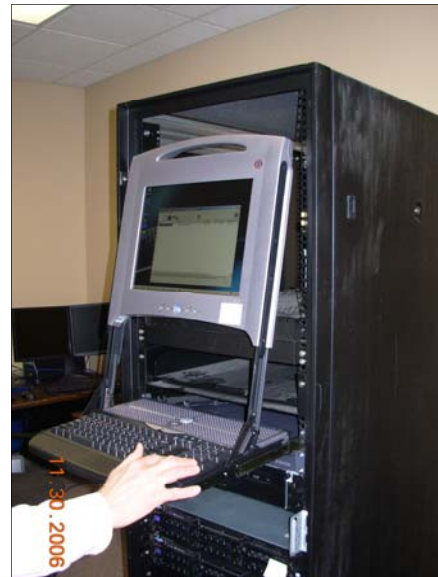
New Data Server with Retractable Monitor and Keyboard

The upgrade includes the installation of a new data server and several new workstations, including all the necessary software licenses to make the system work. Some of the workstations, mainly those being installed in the control room, received a double monitor, allowing the operators to view more than one computer screen at a time. So far, the transition to the new system has been seamless. Its increased reliability has made operating the plant a little less stressful for the plant operators. Even the Plant Superintendent, is getting more sleep at night.

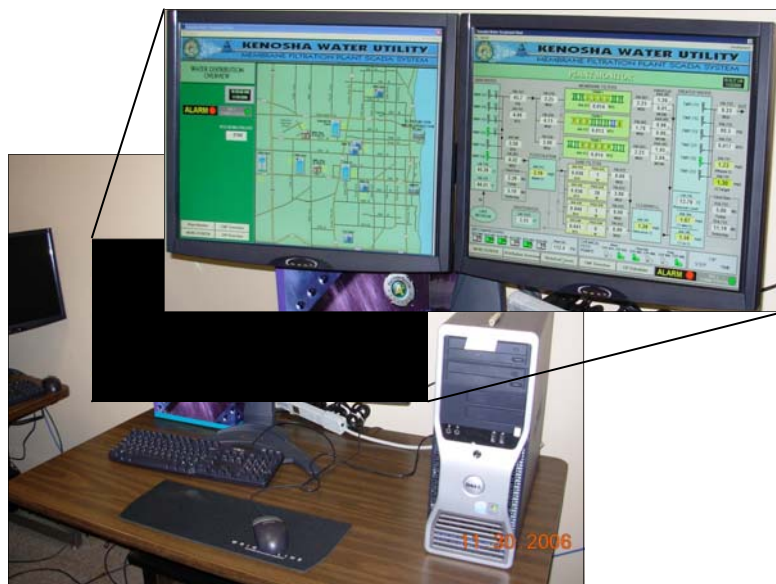
New Workstation with Double Monitor Installed
