Serving Kenosha  
Since 1895

*"Providing and Protecting Kenosha's Greatest Natural Resource...Water"*

May/June 2007

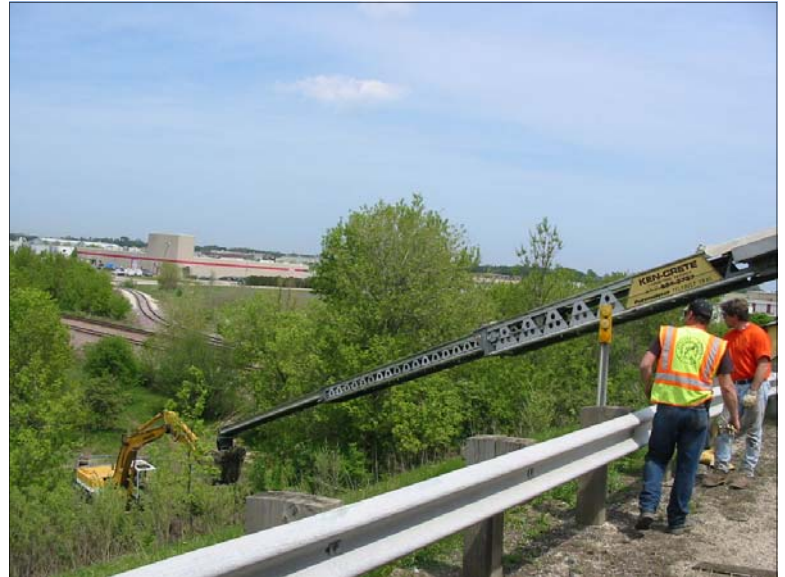
**Water Utility employees look on as backfill material is being lowered down the embankment.**

Being surrounded on three sides by the highway overpass, the UPRR tracks and a large stand of trees, and the only somewhat passable opening having been made into a swamp by the water runoff from the leak, it was virtually impossible to get any large piece of equipment into the site. With some difficulty, an operator from Midwest Construction, Inc. was able to navigate a creek with a track excavator; however there was no way to get a dump truck close enough to deliver the large amount of backfill that would be required to fill in the hole. This required Water Utility supervisors to put their heads together and come up with an ingenious method of delivering backfill to the site. To accomplish this feat, arrangements were made to block off one lane of the Hwy 158 overpass. A special conveyer system was brought in to transport backfill materials from the highway over the side of the overpass and down the embankment to the location of the hole. This whole evolution from start to finish was completed in an amazingly short amount of time.

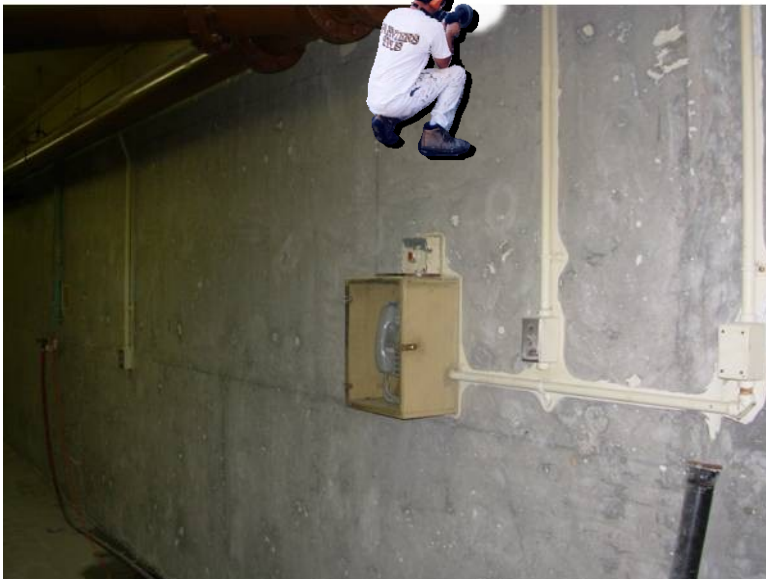
**Tunnel surface after several coats of paint have been ground away.**

Over the years, the utility tunnels at the Wastewater Treatment Plant have received numerous coats of paint. Since the climate in these tunnels remains very damp for most of the year, paint does not adhere well to the concrete substrate. As a result, it doesn't take long for a newly painted surface to begin to spall and flake, thereby causing large paint chips to fall from the ceilings and walls—eventually finding their way into the floor drains. This is a constant maintenance headache for plant operators. In the past, walls were scraped and wire-brushed to remove the flaking paint chips and then a fresh new coat of paint would be applied—only to have the same situation occur in a very short amount of time.

While taking time out to fine tune their equipment, the contractor decided to employ paint grinders to at least get some of the paint removal process started. This turned out to be the best method of all for removing the paint. As can be seen from the photograph to the left, this process leaves behind a very acceptable concrete surface, as opposed to the blasting process that tends to cause a lot more scouring of the concrete. In spite of the fact that most of us may be retired by the time the contractor finishes grinding all the paint from the utility tunnels, the end-product is very good. Actually, the contractor is making good progress and should finish in a few more weeks.

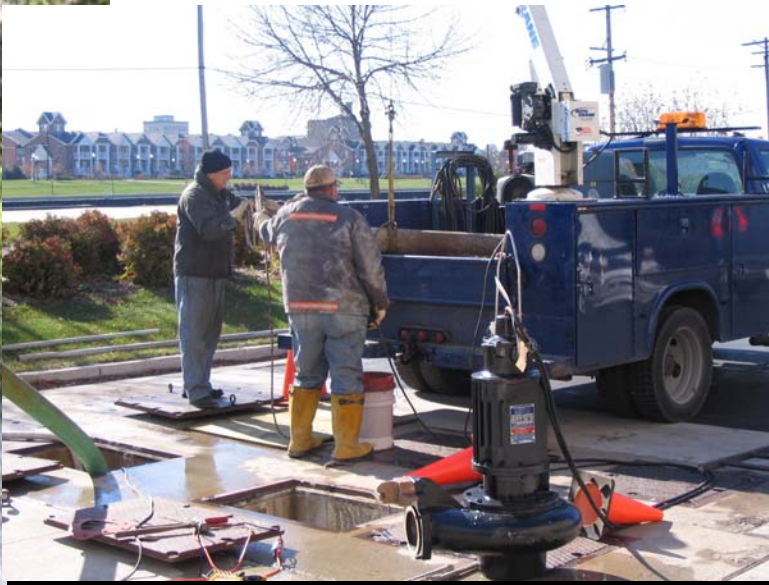
**Employees endure harsh weather and a tight working space to install the new parking lot pumps.**

Looking ahead, the decision was made to start replacing the aging parking lot pumps. Replacing the pumps in-kind proved to be a very costly venture. Additionally, the Engineering Division determined that the existing pumps were not the best fit for the existing performance criteria and were not operating at optimum efficiency. New pumps were selected to more closely match the performance criteria. Furthermore, the cost of these pumps was less than the cost for replacing the pumps in-kind from the original manufacturer. One of the new pumps is depicted in the photograph above.

Prior to ordering the new pumps, careful measurements of the concrete basin and its openings were made to ensure that the pumps would fit properly. As a result, the openings to the concrete vault had to be enlarged slightly and the rail system holding the pumps in-place had to be completely replaced. Initially, only two pumps were replaced, so that they could be tested to ensure that they were up to the task. Once it was determined that the pumps

The two new pumps have recently arrived and have been installed by the mechanics and electricians from the Wastewater Treatment Plant. Now that these pumps are installed, all of the water plant operators are able to breathe a little bit easier, and our Director of Water Production Division, is able to sleep better at night.
