UTILI

GRAM

"Providing and Protecting Kenosha's Greatest Natural Resource ... Water"

November–December 2010

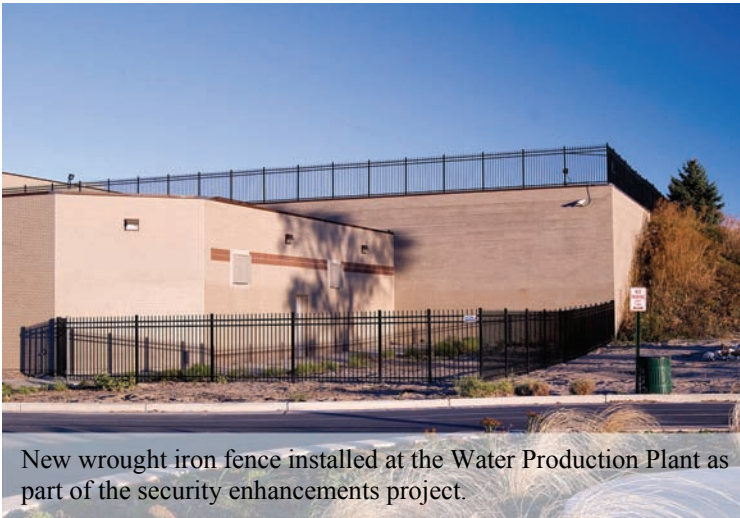
New wrought iron fence installed at the Water Production Plant as part of the security enhancements project.

Recently, two major improvements were made to the Water Production Plant. Included in these improvements is a new wrought iron fence installed at the southeast corner of the plant. This new fence is shown in the photograph to the left, and is part of a larger comprehensive project to implement security enhancements at the plant. Earlier this year, the Utility removed existing asphalt paving adjacent to the plant and constructed a new traffic circle and some additional parking spaces along the road leading to the plant. Additionally, several landscaping improvements were made to the area. These included rubblizing the concrete slab along the harbor channel, placing topsoil over it and seeding the entire area with grass. All of this was done in

an attempt to minimize the flow of vehicular traffic in and around the plant and to especially preclude any vehicle from parking right up next to the building itself. The new wrought iron fence serves a major role in this regard. All that remains to do on this particular security enhancements project is to install some bollards and chain in two areas and finish landscaping the beach area behind the plant.

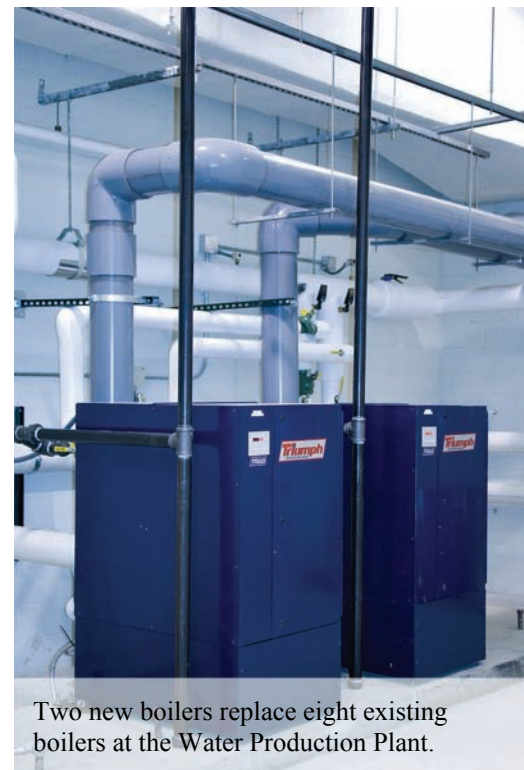
Two new boilers replace eight existing boilers at the Water Production Plant.

Another major improvement made at the Water Production Plant was to replace all eight existing boilers with two new larger, more efficient boilers. When the plant was first constructed, it utilized eight smaller package boilers to heat water that is circulated throughout the plant to heat the spaces within the plant. This was done as an energy savings measure. As temperatures decreased and the heating load at the plant increased, additional boilers would automatically be brought online as necessary to satisfy the demand for heat. Likewise, as temperatures increased and the heating load decreased, boilers would automatically drop offline to conserve energy. Eight boilers were required because at that time there was no way to modulate the boilers. In other words, they either ran full-on or not at all. Having several smaller boilers that could be turned on and off as the heating demand dictated was an excellent means of conserving energy. Today's modern boilers are able to modulate up and down within a large temperature range; therefore they are able to keep pace with heating requirements, while conserving the maximum amount of energy. For this reason, the decision was made to replace all eight boilers with two new high efficiency boilers with a total combined heating capacity of 2 million BTUs.

You can well imagine that replacing eight boilers with two would eliminate a whole lot of piping and other appurtenances. You can see from the photograph to the right how clean and less cluttered the new installation turned out to be. Where there once stood eight pairs of hot water supply and return pipes and eight pairs of intake and exhaust air pipes, now there are only two pairs of each.

The major driving force behind the Utility's decision to replace the boilers at this time was the fact that only five of the eight existing boilers continued to be functional. The boilers themselves are no longer manufactured and there are limited replacement parts available for making repairs. When selecting the replacement boilers, the Utility tried to identify boilers that are commonly used throughout the industry; therefore replacement parts should be more readily available. Of course, the Utility also took into consideration factors such as overall energy efficiency and reliability when selecting the replacement boilers. With winter now in its full throw, operators at the Water Production Plant can rest easier knowing that they have a reliable heating system with plenty of heating capacity.

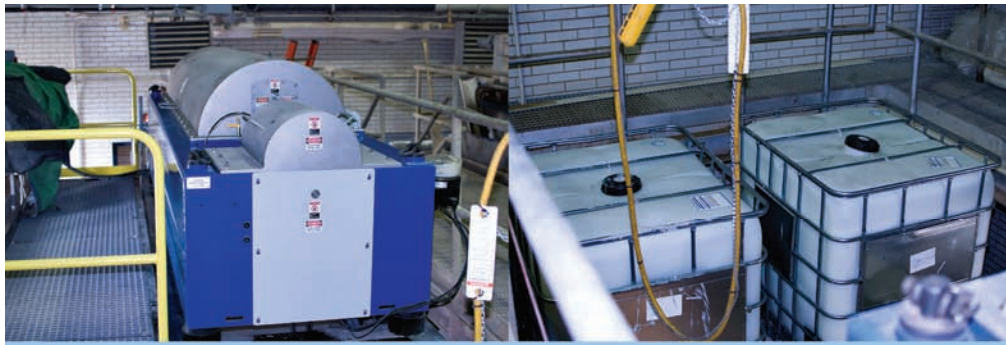
1. Newly installed centrifuge in operation dewatering sludge.

Following a very tedious and time consuming installation process, the new centrifuge at the Wastewater Treatment Plant was finally placed into operation in November of this year. The centrifuge is being used in lieu of the existing plate and frame filter presses to dewater the sludge before it is transported to the landfill. In fact, a single centrifuge will easily do the work of three filter presses. One of the existing filter presses was removed earlier this year to make room for the new centrifuge. The Utility plans to keep the two remaining filter presses for the time being; however they will not be used nearly as much in the future.

The new centrifuge was manufactured by Centrisys Centrifuge Systems (Centrisys), a Kenosha-based manufacturing company. It was installed at the Wastewater Treatment Plant as a joint effort between the Utility and Centrisys. Workers hired by Centrisys set the unit in place, while mechanics and electricians from the plant performed the necessary plumbing and electrical installations. Unit start up was performed primarily by technicians from Centrisys with some assistance from operators at the plant. Now that the unit is up and running, it will take some time to optimize its performance and determine the most efficient manner in which to

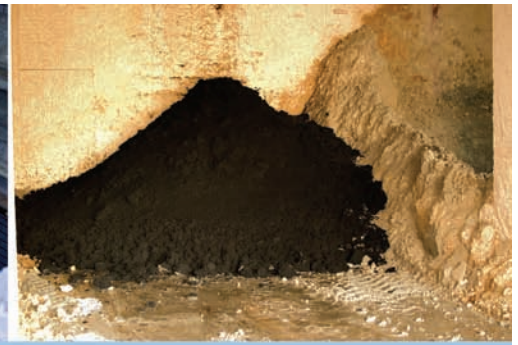
3. Finished product—dewatered sludge ready to be hauled to the landfill.

presses in that they consume lesser amounts of chemicals to dewater the sludge. More than 50 percent by weight of the sludge that is dewatered by the filter presses is made up of lime and ferric chloride. With the absence of lime and ferric chloride in the dewatered sludge, nearly twice as much sludge can be hauled away to the landfill in a single truckload.

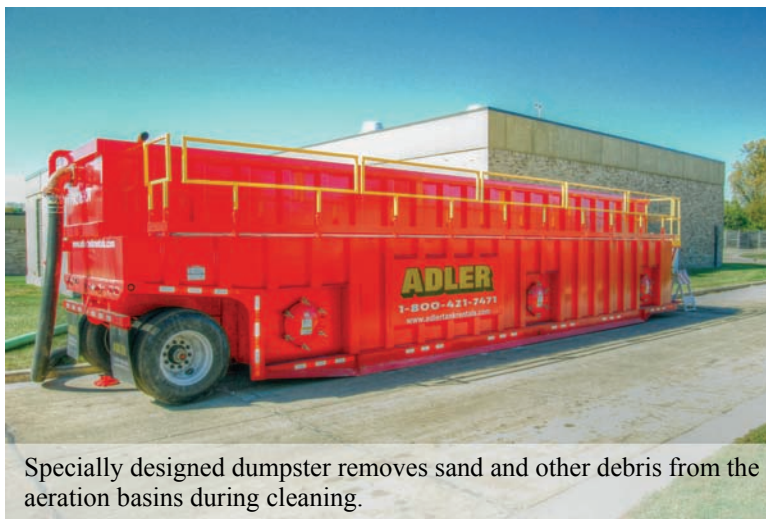
Specially designed dumpster removes sand and other debris from the aeration basins during cleaning.

This specially designed trailer was used by the Wastewater Treatment Plant to separate sand from water during the recent cleaning of the aeration basins. It is estimated that several hundred tons of sand were removed in the process. In years past, the sand would have been pumped back to the front of the plant only to return again.
